Scientific paper

Performance Recovery of Fire-damaged Concrete by Impregnation of NaOH-added Lithium Silicate

doi:10.3151/jact.22.751

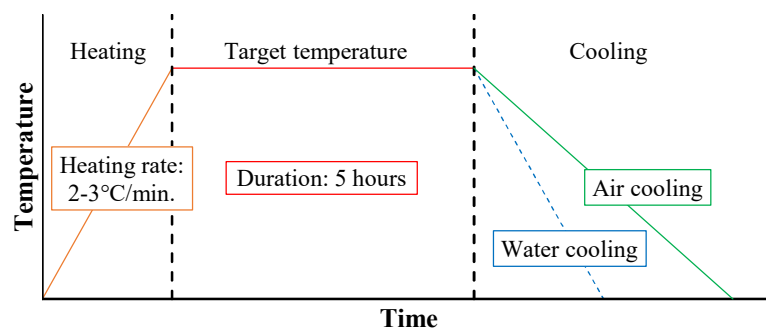
Fig. 1 Heating and cooling regime.

The specimens of Groups 2 and 3 were heated using an electric furnace after the 28-day water curing. The heating and cooling regimes are shown in **Fig. 1**. The target heating temperatures were set to be 300°C, 500°C, and 650°C, and

were maintained for 5 hours. To prevent the specimens from spalling due to rapid heating, the heating rate was set as 3.0°C/min. Ichinose *et al.* (2002) reported that the heating rate within the range of 2.5-7.5°C/min. has almost no effect on degradation of compressive strength at elevated temperatures. The heating experiment in the range of 100-700°C at a heating rate of 0.77°C/min. or 1.0°C/min., performed by Kim *et al.* (2014), showed that when the target temperature was maintained for 60 minutes, the difference in the internal and external temperatures of cylindrical specimen of 100 mm in diameter and 200 mm in height was within 5°C. Thus, although we did not measure the internal temperatures of the specimens, long-time (5 hours) maintenance of the target temperature allowed the internal temperatures of specimens with 100 mm of diameter or of cross-sectional side to reach the temperature of the electric furnace.

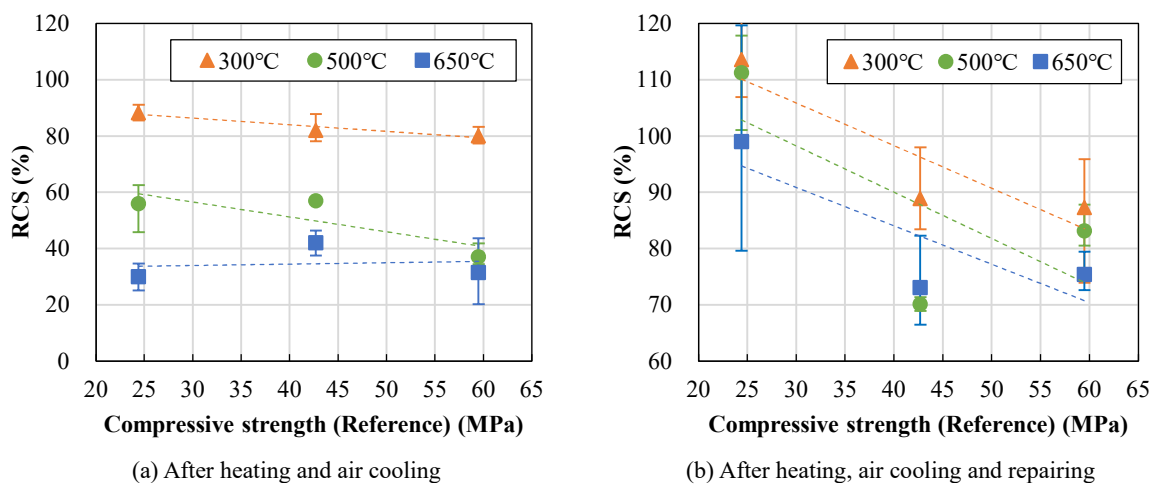
Fig. 2 Relationship between residual compressive strength (RCS) and original compressive strength.

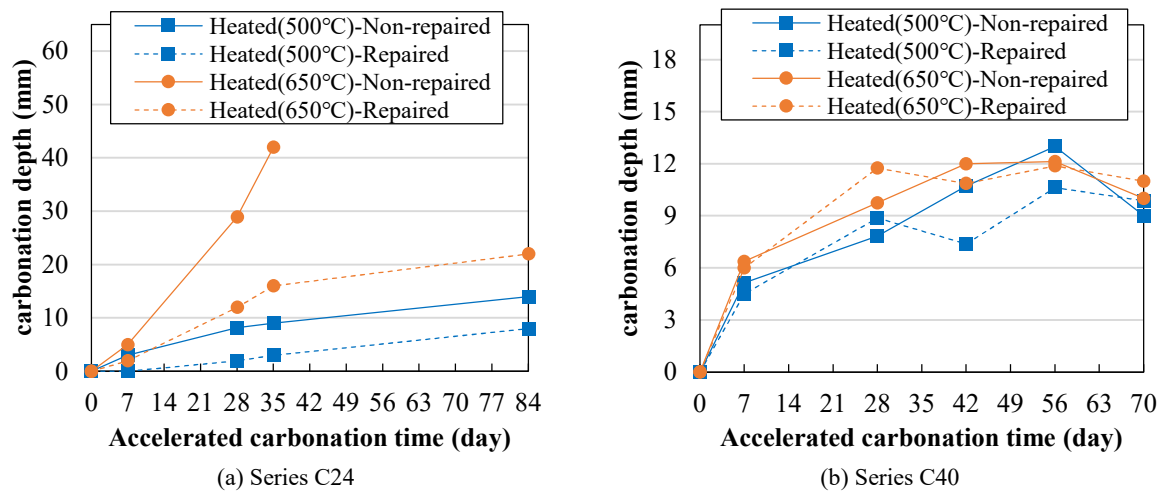
Fig. 4 Carbonation depths of non-repaired and repaired concretes.

elapsed time are shown in Fig. 4 for specimens with repairing or not after heating/air-cooling.

When heated at 500°C, the carbonation depth of the C24 specimen without repairing was 8 mm after 28 days, and 14 mm after 84 days from the beginning of the accelerated carbonation test. On the other hand, for the C24 specimen with repairing, the carbonation depth was 2 mm after 28 days, and 8 mm after 84 days. When heated at 650°C, the carbonation depth of the C24 specimen without repairing reached 33 mm at 28 days, and 42 mm at 35 days from the beginning of the accelerated carbonation test, and thus the measurement was stopped after 35 days because the radius of the specimen was 50 mm. However, for the repaired C24 specimen, the carbonation depth was 12 mm after 28 days, and 16 mm after 35 days. Even after 84 days of carbonation time, the carbonation depth was only 22 mm. From these results, it was found that the carbonation resistance of concrete decreased significantly after heated at the elevated temperatures, especially at 650°C. This is due to the changes of internal structure caused by the

decomposition of hydrates and the formation of cracks. It was also clearly found that the repairing with the NW-LS solution increased the carbonation resistance of the heated concrete.

On the other hand, as shown in **Table 5** and **Fig. 4(b)**, for the same heating temperature and the same carbonation time, the carbonation depth of the C40 specimen was less than that of the C24 specimen. Feng *et al.* (2023) also found that the pH of the heated concrete during the accelerated carbonation test decreased greatly with the increase of heating temperature, which was mainly because the increase of porosity of the heated concrete promoted the diffusion of CO_2 . They also pointed out that the smaller the water-cement ratio, the less the decrease in the pH. That is to say, the loss of carbonation resistance of heated concrete with higher strength is small, which is consistent with the result of this study. In the repaired C24 concretes, the tendency for the depth of carbonation being reduced by NW-LS solution treatment was clearly observed, i.e., the carbonation resistance was improved by repairing. However, in the C40 concrete, little difference in the carbonation depth was observed between the repaired and non-repaired specimens, regardless of the heating temperature. This is because the heated C40 concrete had a small carbonation depth before the repairing, i.e., it still had a relatively high carbonation resistance, so the effect of the repairing was limited. In other words, the NW-LS solution was more effective in improving the carbonation resistance of ordinary strength concrete (<36 MPa) after a fire.

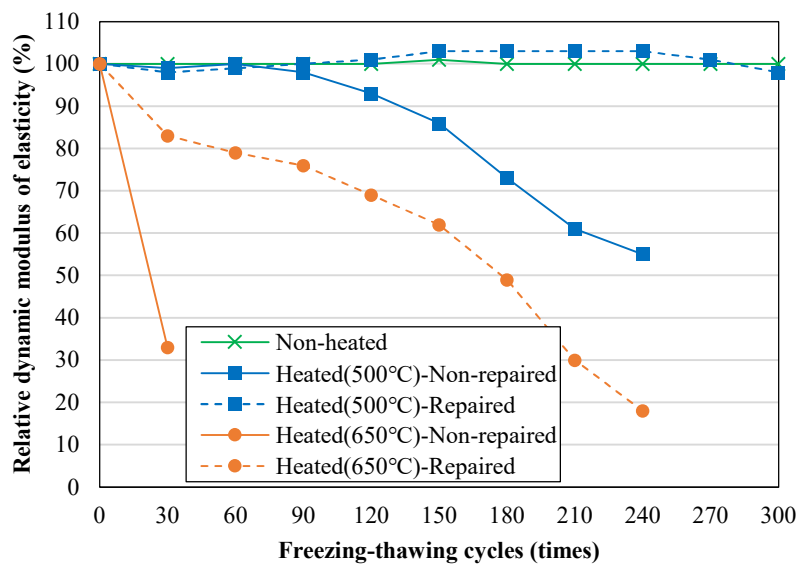
Fig. 5 Relationship between relative dynamic modulus of elasticity and freezing-thawing cycles.

after 300 cycles. This is because the concrete used the air-entraining water reducer, thus had 4.5% of air content. However, for the specimen heated at 500°C but not repaired, the relative dynamic modulus gradually decreased after about 100 cycles and was halved after 240 cycles, and the mass loss reached 3.6% after 270 cycles. For the specimen heated at 650°C but not repaired, the relative dynamic modulus of elasticity decreased rapidly, even it could not be measured after 30 cycles due to severe damage caused by the frost action. After 60 cycles, the 650°C-heated/non-repaired specimen was broken. That is to say, the frost resistance of concrete was greatly decreased after subjected to an elevated temperature.

On the other hand, for the specimen heated at 500°C and then repaired by the NW-LS solution, the relative dynamic modulus of elasticity remained almost 100% after 300 cycles, which indicates that the 500°C-heated concrete reached the equivalent frost resistance to the unheated concrete after repaired with the NW-LS solution. For the repaired specimen that was heated at 650°C, although its relative dynamic elasticity modulus was lower than 60% after 150 cycles, its frost resistance was greatly increased by the repairing, compared to the non-repaired specimen. Therefore, the application of the NW-LS solution can contribute to improvement of frost resistance of heated concrete.

According to **Figs. 5** and **6**, when the heating temperature was not above 500°C, the repairing can restore the frost resistance of heated concrete to the original level before heating.

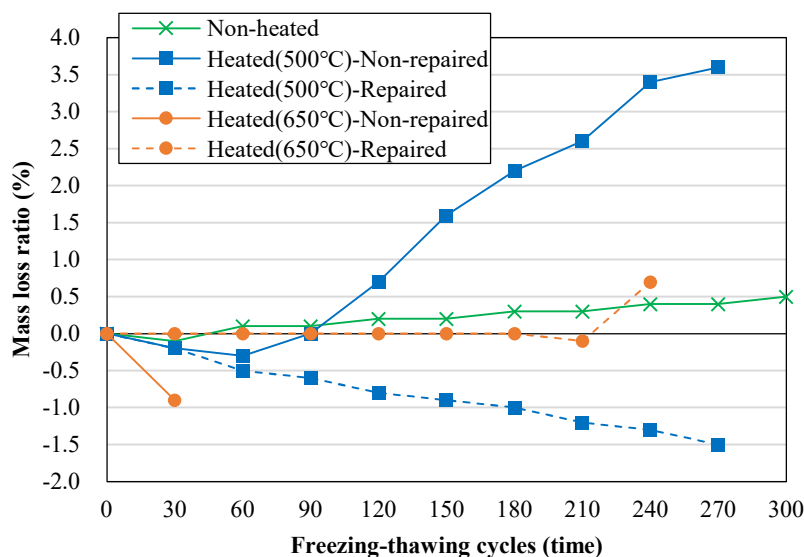
Fig. 6 Relationship between mass loss ratio and freezing-thawing cycles.

The mass of the specimen, which was heated at 650°C but non-repaired, gained 0.9% after 30 cycles, though the relative dynamic elasticity modulus was only 33%. The mass gain may be because the mass loss due to surface spalling was smaller than the increase of water absorption resulting from the pore enlargement within the specimen after freezing-thawing cycle. The rehydration of decomposed hydrates may be another reason. As shown in Photo (c-2) of **Table 7**, severe surface spalling did not occur, though wide cracks were found. However, the mass of the 500°C-heated/non-repaired specimen decreased with the freezing-thawing

cycle. After 270 cycles, the mass loss reached 3.6%. As shown in Photo (a-2) of **Table 6**, surface spalling resulted in the mass loss.

As shown in **Fig. 6**, we found that the mass of the 500°C-heated/repaired specimen increased with the freezing-thawing recycle, but the 650°C-heated/repaired specimen showed a decline tendency. As shown in Photos (b-2) and (d-2) of **Table 6**, after 270 cycles, the surface degradation of the 500°C-heated/repaired specimen was not observed. Its mass gain was thus because of the water absorption increase, rehydration of decomposed hydrates, and the continuous silicate reaction between LS and Ca²⁺. However, the surface damage was obviously found from 240 cycles for the 650°C-heated/repaired specimen. By comparing Photos (c-3) and (d-3) in **Table 7**, here is no doubt that the repairing with the NW-LS solution can improve the frost resistance of the heated concrete.

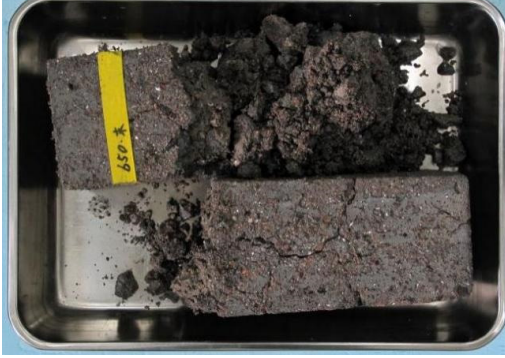
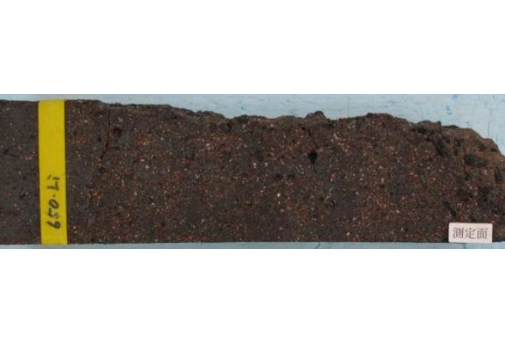
Table 6 Surface appearance of specimen before and after the freezing-thawing test.

(a-1) Heated (500°C)-non-repaired, 0 cycle	(b-1) Heated (500°C)-repaired, 0 cycle

(a-2) Heated (500°C)-non-repaired, 270 cycles	(b-2) Heated (500°C)-repaired, 270 cycles

(c-1) Heated (650°C)-non-repaired, 0 cycle	(d-1) Heated (650°C)-repaired, 0 cycle

(c-2) Heated (650°C)-non-repaired, 30 cycles	(d-2) Heated (650°C)-repaired, 240 cycles

(c-3) Heated (650°C)-non-repaired, 60 cycles	(d-3) Heated (650°C)-repaired, 270 cycles
